**Flood Control Project Maintenance
Levee Inspections**

Maintenance Issue Types Only, Levee Inspection Report By Mile - Fall 2018

Lake County Watershed Protection District

Waterway	Bank	Unit Miles	Inspection Start/End	Inspector
Unit No. 01 Middle Creek	Left	3.35	09/26/2018 09/26/2018	Bob Duffey

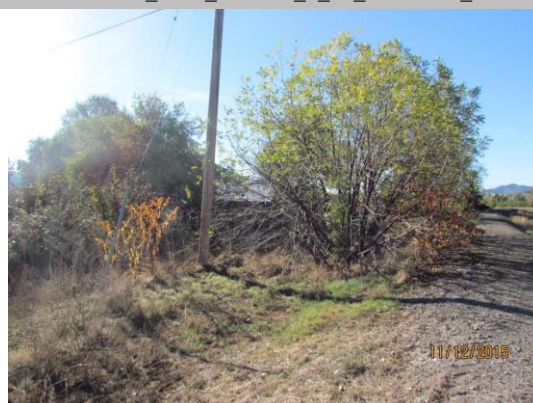
Photo 1 of 1 : FA_2018_NA0009_3_11_20180905_00006.jpg

LM Start	0.26	Rating **	M	Issue No.	11
LM End	0.26	Issue Type +	Ma	Location *	LS
Category	Earthen Levee			GPS Latitude/Longitude	
				Start	End
Item	Trim / Thin Trees			39.186777 °	39.186777 °
				-122.908102 °	-122.908102 °
DWR ID	DWR_NA0009_01_s_2013_11				
Comment Code					
T3 : Trim and thin trees to allow visibility of the ground and room to flood fight.					
Inspector Comment

View of the overgrown trees at the landside slope.

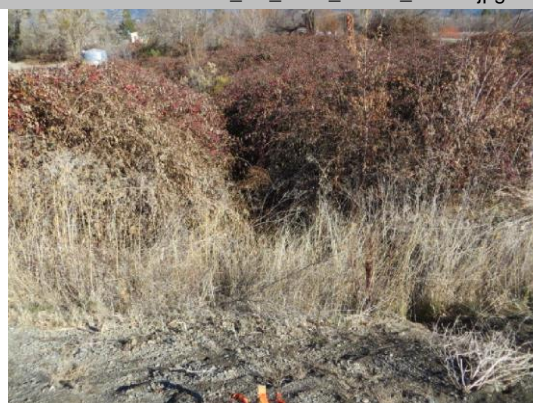
Photo 1 of 3 : UCIP_FA_2018_26987_49853.jpg

LM Start	2.26	Rating **	A/W	Issue No.	537
LM End	2.26	Issue Type +	Ma	Location *	
Category	Supplemental			GPS Latitude/Longitude	
				Start	End
Item	DWR UCIP LMA Responsibility			39.160327 °	39.160327 °
				-122.913998 °	-122.913998 °
DWR ID	21240				
Comment Code					
Inspector Comment					
FS_ID:26987					
DS_ID:21240					
EP_NO: N/A					
Repair Type: No Action Needed					
Crossing Status: Found					
UCIP Comments:					
FIELD_STRUCT_DESC: 2 of 2: 36-inch corrugated metal drainage pipe through the levee, 9 feet below the crown. Flap gate on the waterside (WS) end. Concrete headwalls on both ends. (two 36-inch pipes [HLM 2.26] retained under Automatic Board Order (ABO) issued as Permit No. 11460, 1975 - Robert L. and Lavona Gentry). [Additional Reference(s): DWR Levee Log, 2005. USACE Sacramento O&M Manual 506.2, August 1961, (HLM 2.26)].					
FS Date: 1/14/2014

Pipe and Concrete headwall visible on LS toe.

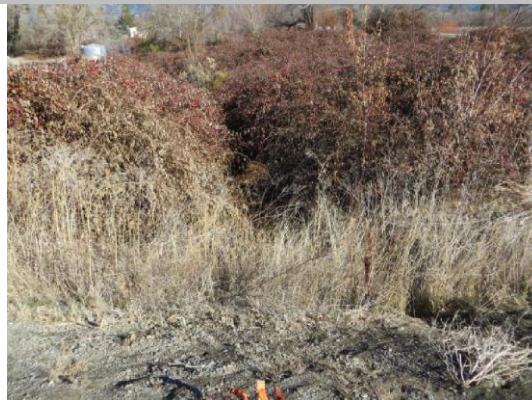
Photo 1 of 3 : UCIP_FA_2018_26986_49849.jpg

LM Start	2.26	Rating **	A/W	Issue No.	538
LM End	2.26	Issue Type +	Ma	Location *	
Category	Supplemental			GPS Latitude/Longitude	
				Start	End
Item	DWR UCIP LMA Responsibility			39.160272 °	39.160272 °
				-122.913966 °	-122.913966 °
DWR ID	21197				
Comment Code					
Inspector Comment					
FS_ID:26986 DS_ID:21197 EP_NO: N/A Repair Type: No Action Needed Crossing Status: Found UCIP Comments: FIELD_STRUCT_DESC: 1 of 2: 36-inch corrugated metal drainage pipe through the levee, 9 feet below the crown. Flap gate on the waterside (WS) end. Concrete U-shaped headwalls on both ends. (two 36-inch pipes [HLM 2.26] retained under Automatic Board Order (ABO) issued as Permit No. 11460, 1975 - Robert L. and Lavona Gentry). [Additional Reference(s): DWR Levee Log, 2005. USACE Sacramento O&M Manual 506.2, August 1961, (HLM 2.26)]. FS Date: 1/9/2014

Concrete headwall and pipe visible on LS toe at end of drainage swale.

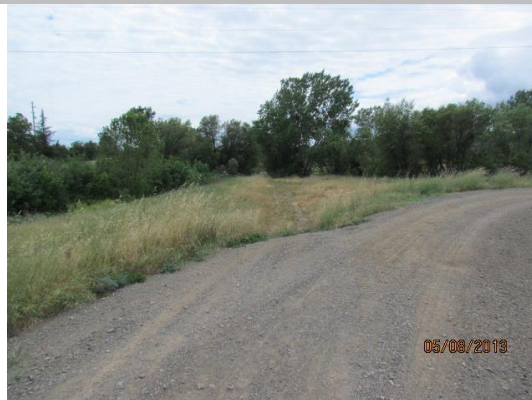
Photo 1 of 1 : FA_2018_NA0009_3_13_20180905_00007.jpg

LM Start	2.29	Rating **	M	Issue No.	13
LM End	2.29	Issue Type +	Ma	Location *	WS
Category	Earthen Levee			GPS Latitude/Longitude	
				Start	End
Item	Slope Stability			39.160285 °	39.160285 °
				-122.913481 °	-122.913481 °
DWR ID	DWR_NA0009_01_s_2013_13				
Comment Code					
S3 : Repair the levee slope damaged by vehicle traffic and prevent access where possible.					
Inspector Comment

View of the vehicle erosion along the waterside slope.

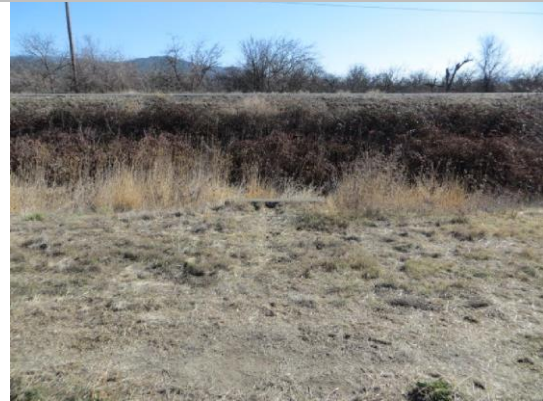
Photo 2 of 3 : UCIP_FA_2018_27004_49861.jpg

Concrete U-shaped headwall on WS berm.

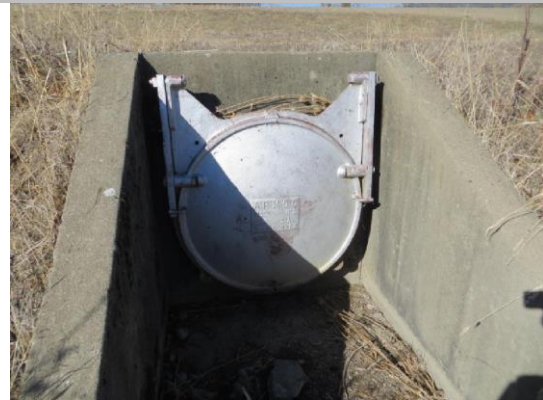
Photo 3 of 3 : UCIP_FA_2018_27004_49860.jpg

Concrete U-shaped headwall and flap gate on WS berm.

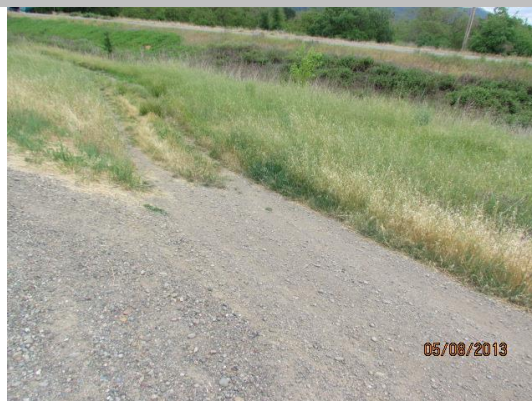
Photo 1 of 1 : FA_2018_NA0009_3_14_20180905_00008.jpg

LM Start	2.36	Rating **	M	Issue No.	14
LM End	2.36	Issue Type +	Ma	Location *	WS
Category	Earthen Levee			GPS Latitude/Longitude	
				Start	End
Item	Slope Stability			39.161153°	39.161153°
				-122.912740°	-122.912740°
DWR ID	DWR_NA0009_01_s_2013_14				
Comment Code					
S3 : Repair the levee slope damaged by vehicle traffic and prevent access where possible.					
Inspector Comment

View of the vehicle erosion along the waterside slope.

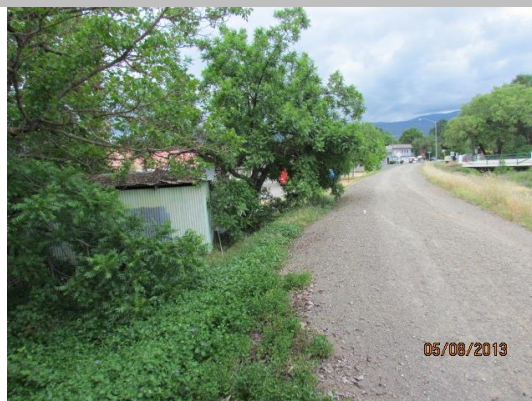
Photo 1 of 1 : FA_2018_NA0009_3_15_20180905_00009.jpg

LM Start	2.38	Rating **	M	Issue No.	15
LM End	2.41	Issue Type +	Ma	Location *	LS
Category	Earthen Levee			GPS Latitude/Longitude	
				Start	End
Item	Trim / Thin Trees			39.161381 °	39.161708 °
				-122.912551 °	-122.912168 °
DWR ID	DWR_NA0009_01_s_2013_15				
Comment Code					
T1 : Trim trees to at least five feet above ground level.					
Inspector Comment					
trim the trees to at least 5 feet above the ground for visibility and remove the vegetation from the slope.

Trim the trees up 5 feet to allow visibility.

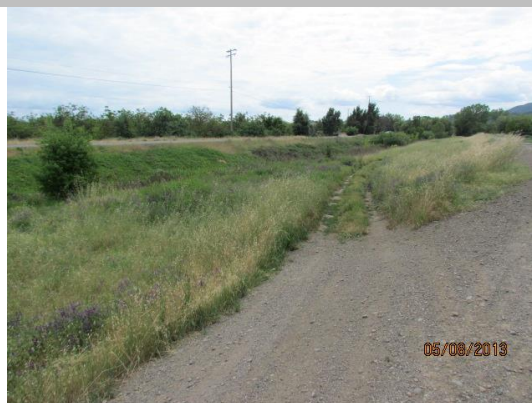
Photo 1 of 1 : FA_2018_NA0009_3_16_20180905_00010.jpg

LM Start	2.40	Rating **	M	Issue No.	16
LM End	2.40	Issue Type +	Ma	Location *	WS
Category	Earthen Levee			GPS Latitude/Longitude	
				Start	End
Item	Slope Stability			39.161601°	39.161601°
				-122.912303°	-122.912303°
DWR ID	DWR_NA0009_01_s_2013_16				
Comment Code					
S3 : Repair the levee slope damaged by vehicle traffic and prevent access where possible.					
Inspector Comment

View of the vehicle erosion along the waterside slope.

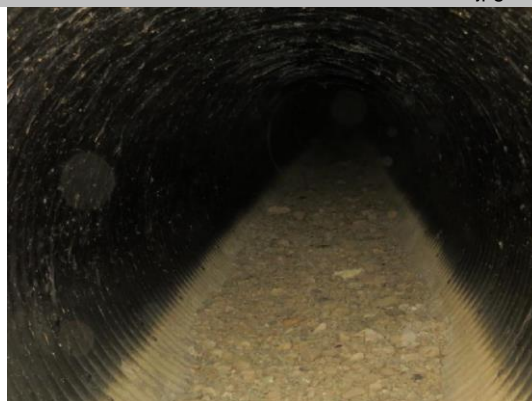
Photo 3 of 3 : UCIP_FA_2018_27066_50047.jpg

Pipe with some sediment at flowline.

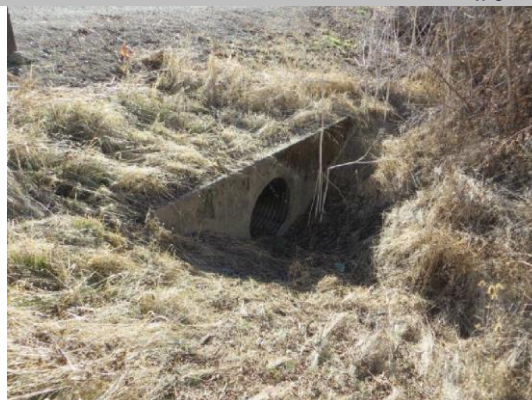
Photo 1 of 3 : UCIP_FA_2018_27184_50322.jpg

Concrete headwall and pipe on LS toe.

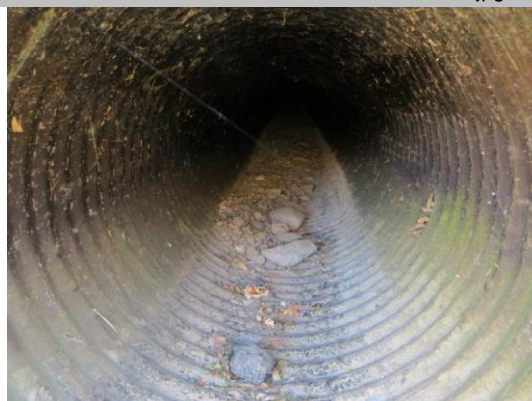
Photo 2 of 3 : UCIP_FA_2018_27184_50321.jpg

Pipe at inlet.

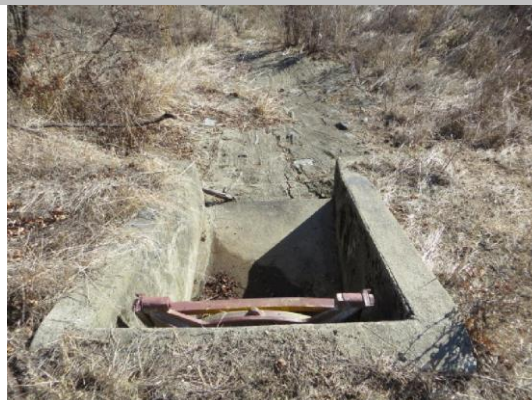
Photo 3 of 3 : UCIP_FA_2018_27184_50320.jpg

Flapgate and concrete headwall on WS toe.

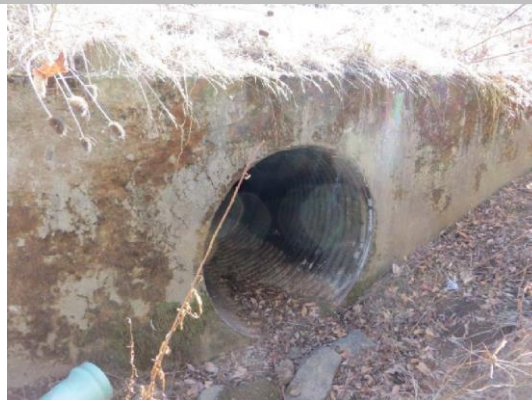
Photo 3 of 3 : UCIP_FA_2018_27192_50324.jpg

Pipe and concrete headwall at LS toe.

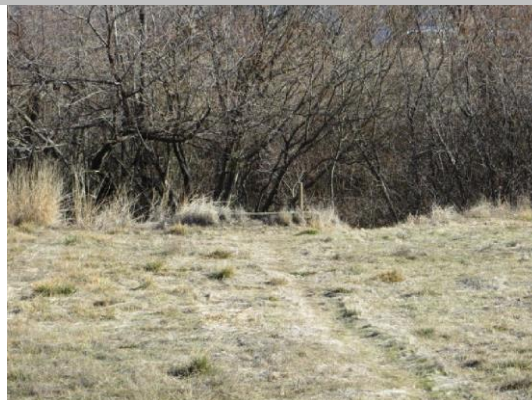
Photo 3 of 3 : UCIP_FA_2018_27199_50387.jpg

Concrete headwall and flapgate visible on waterside berm

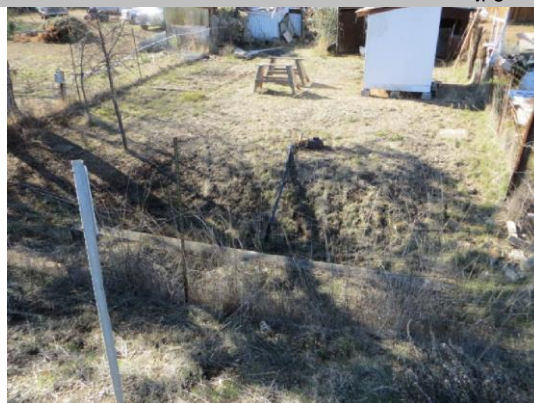
Photo 1 of 3 : UCIP_FA_2018_27208_50411.jpg

LM Start	0.55	Rating **	M	Issue No.	39
LM End	0.55	Issue Type +	Ma	Location *	
Category	Supplemental			GPS Latitude/Longitude	
				Start	End
Item	DWR UCIP LMA Responsibility			39.183130 °	39.183130 °
				-122.912198 °	-122.912198 °
DWR ID	21210				
Comment Code					
Inspector Comment					
FS_ID:27208 DS_ID:21210 EP_NO: 11482 Repair Type: Non-Urgent Crossing Status: Found UCIP Comments: Fence on LS slope creates access issue. FIELD_STRUCT_DESC: 36-inch corrugated metal drainage pipe through the levee, 9 feet below the crown. Flap gate on the waterside (WS) end. Concrete headwalls on both ends. (36-inch pipe [HLM 0.54] retained under ABO No. 11482, 1975 - George R. and Gladys Schneider). [Additional Reference(s): DWR Levee Log, 2005. USACE Sacramento O&M Manual 506.2, August 1961, (HLM 0.54)]. FS Date: 1/14/2014

Concrete headwall on LS toe.

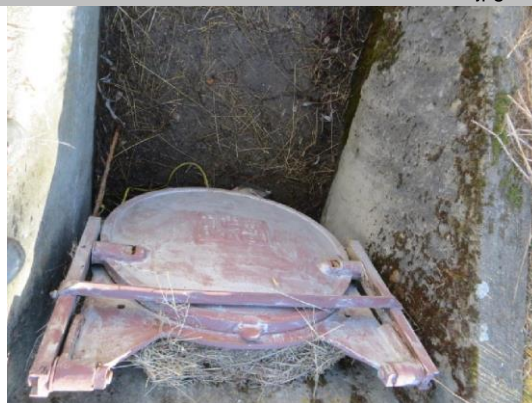
Photo 3 of 3 : UCIP_FA_2018_27208_50409.jpg

Flapgate and concrete headwall on WS berm.

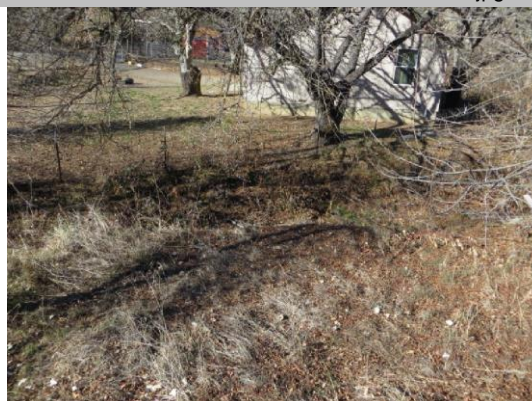
Photo 3 of 3 : UCIP_FA_2018_27583_51200.jpg

Pipe visible on LS toe.

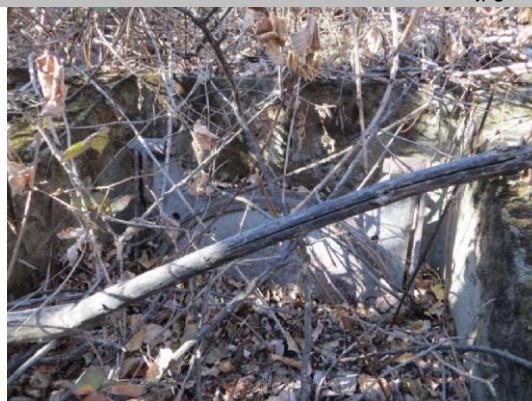
Photo 3 of 3 : UCIP_FA_2018_42994_51215.jpg

Flapgate and concrete headwall visible off WS berm.

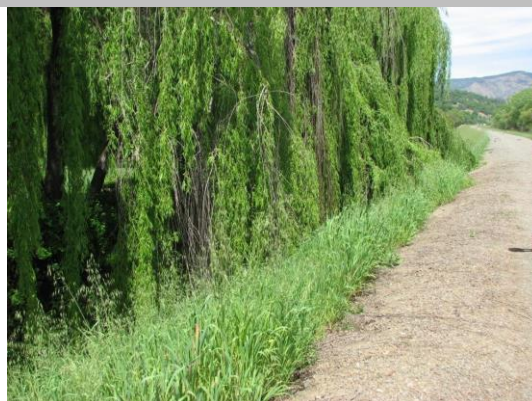
Photo 1 of 1 : FA_2018_NA0009_4_18_20180905_00009.jpg

View of the overgrown willow trees at the landside levee slope.

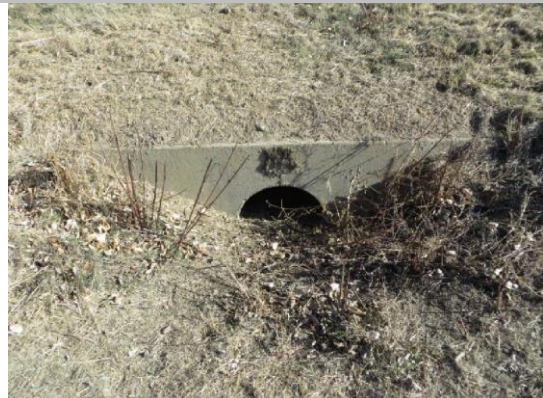
Photo 3 of 3 : UCIP_FA_2018_27630_51281.jpg

Concrete headwall and pipe visible at LS toe.

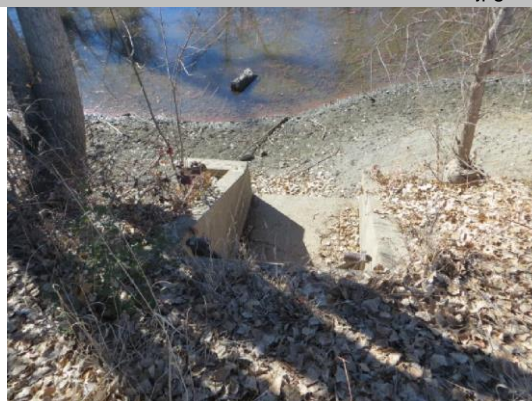
Photo 2 of 3 : UCIP_FA_2018_27863_51541.jpg

Concrete headwall and flapgate visible at WS berm.

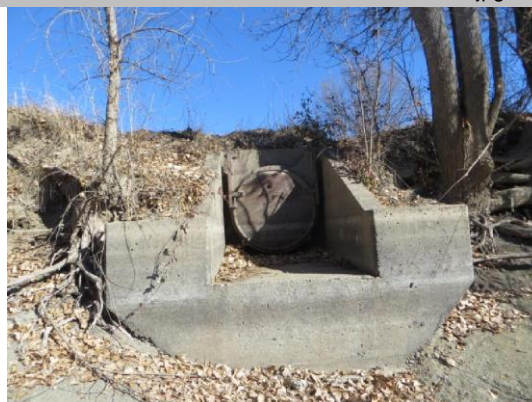
Photo 3 of 3 : UCIP_FA_2018_27863_51540.jpg

Concrete headwall and flapgate visible at WS berm.

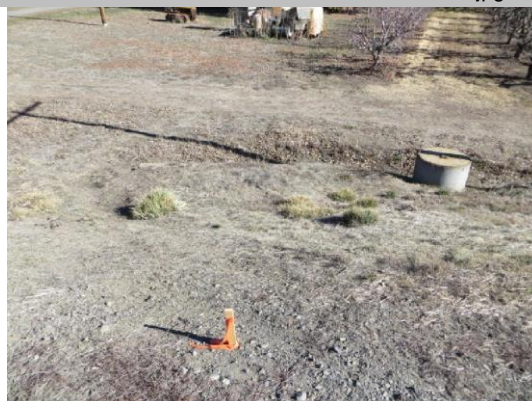
Photo 1 of 3 : UCIP_FA_2018_27892_51591.jpg

Concrete headwall visible next to concrete standpipe on LS toe.

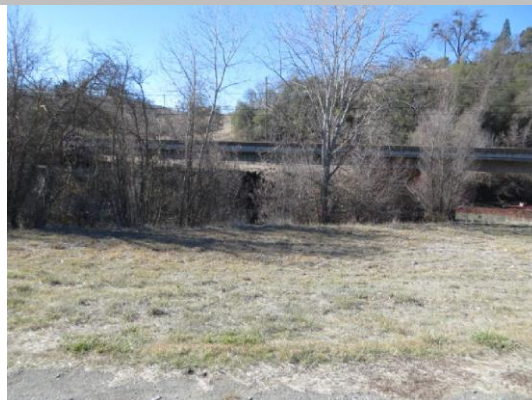
Photo 2 of 3 : UCIP_FA_2018_27892_51590.jpg

Concrete outfall visible off WS berm.

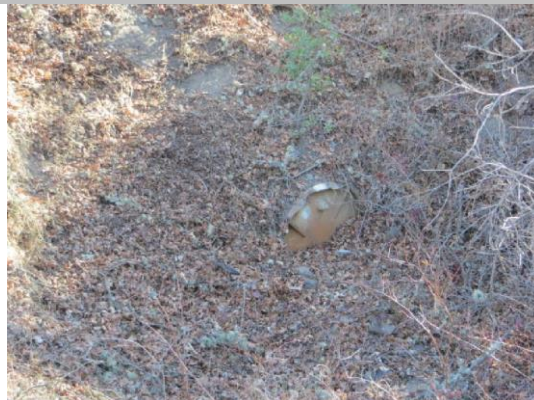
Photo 1 of 3 : UCIP_FA_2018_27893_51595.jpg

Plugged pipe visible on WS toe of roadway.

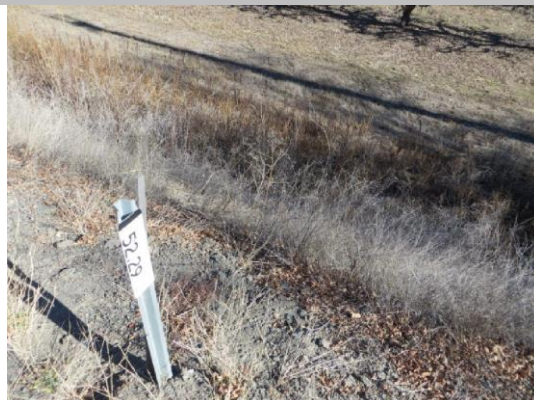
Photo 2 of 3 : UCIP_FA_2018_27893_51594.jpg

Roadway marker 52.29 on LS and WS shoulder mark pipe location on crown.

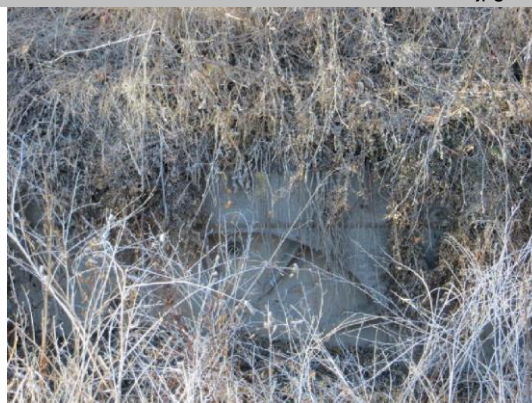
Photo 3 of 3 : UCIP_FA_2018_27893_51596.jpg

Concrete headwall and plugged pipe visible on LS toe of roadway.

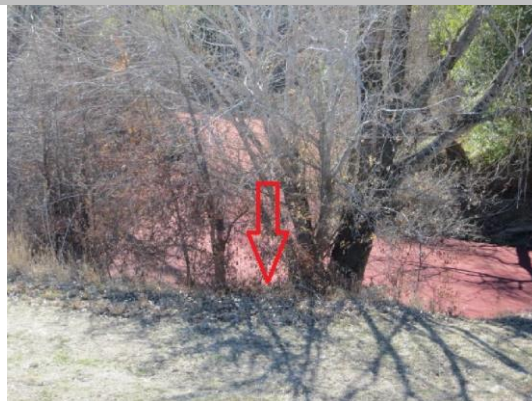
Photo 1 of 3 : UCIP_FA_2018_27894_51599.jpg

Flapgate and headwall off WS toe.

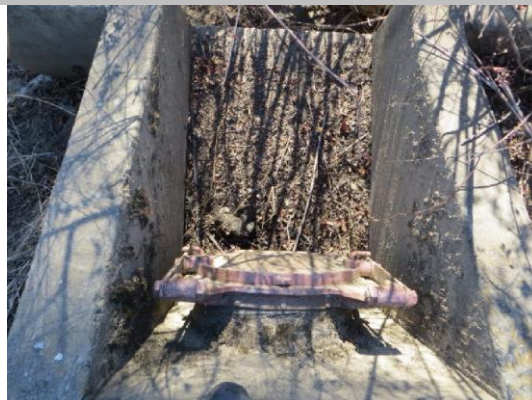
Photo 2 of 3 : UCIP_FA_2018_27943_51641.jpg

Headwall and flapgate on WS berm.

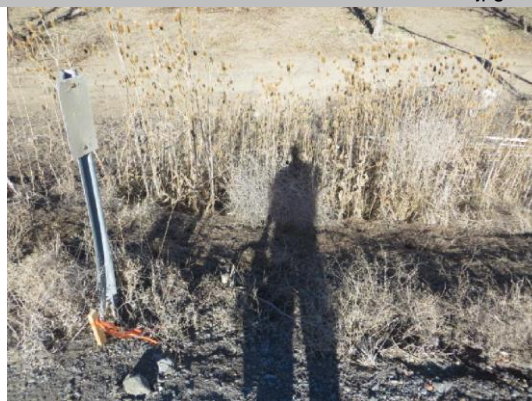
Photo 3 of 3 : UCIP_FA_2018_27943_51640.jpg

Pipe location marked on crown by flasher.

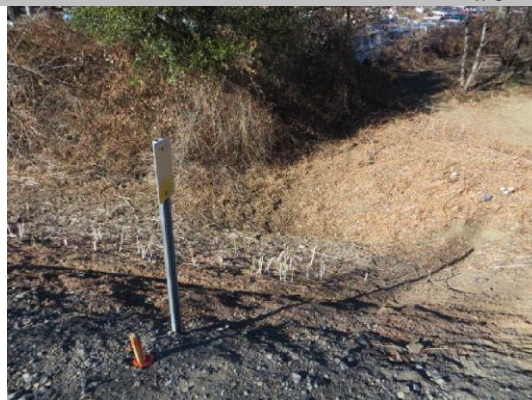
Photo 1 of 3 : UCIP_FA_2018_27944_51646.jpg

Flasher on crown marks pipe location.

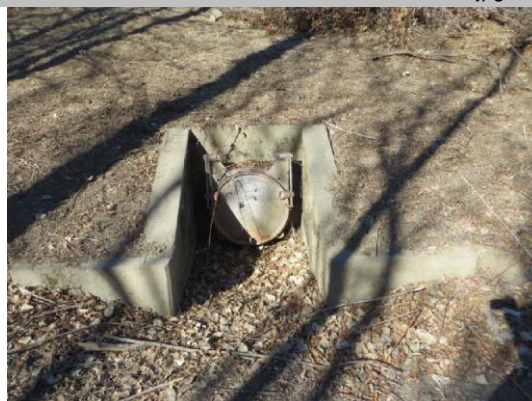
Photo 2 of 3 : UCIP_FA_2018_27944_51645.jpg

Flapgate and headwall visible on WS toe.

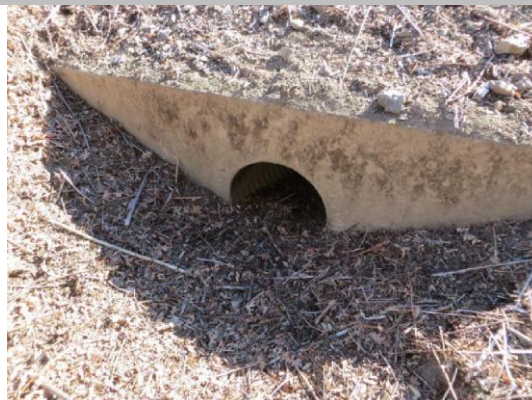
Photo 3 of 3 : UCIP_FA_2018_27944_51644.jpg

Concrete headwall on LS toe.

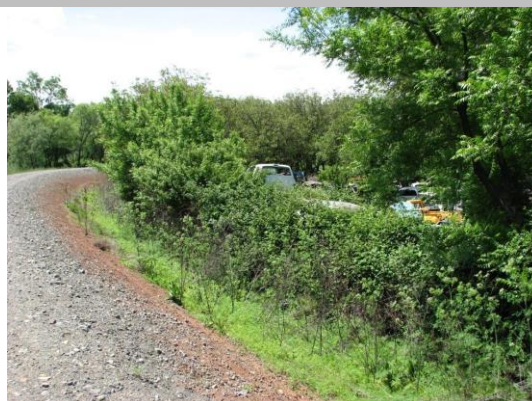
Photo 1 of 1 : FA_2018_NA0009_5_12_20180905_00003.jpg

5/2/2016: Dense bushes and vines covering fence along vehicle junk yard.

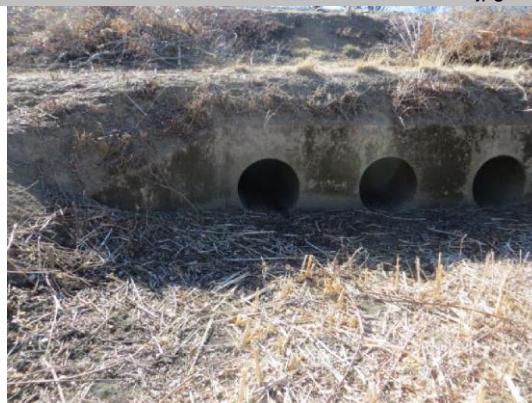
Photo 1 of 3 : UCIP_FA_2018_27963_51662.jpg

Concrete headwall on LS toe.

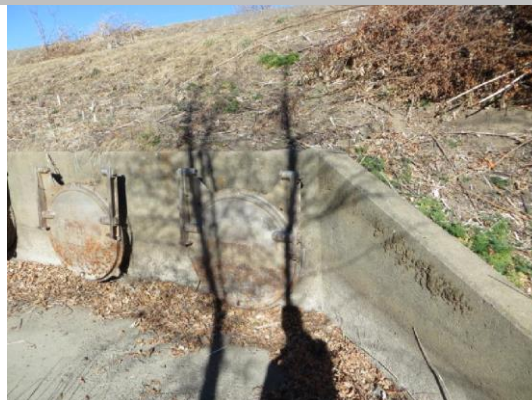
Photo 3 of 3 : UCIP_FA_2018_27963_51660.jpg

Flapgate on headwall at WS toe.

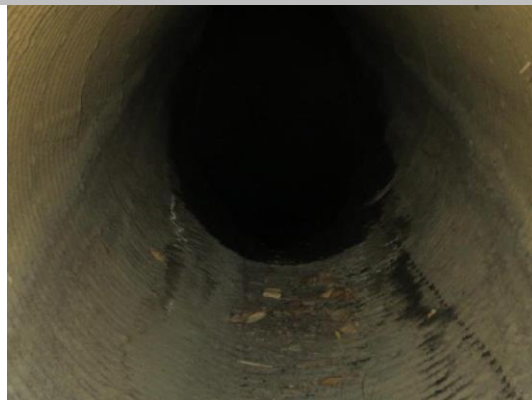
Photo 2 of 3 : UCIP_FA_2018_27964_51664.jpg

Pipe from LS toe.

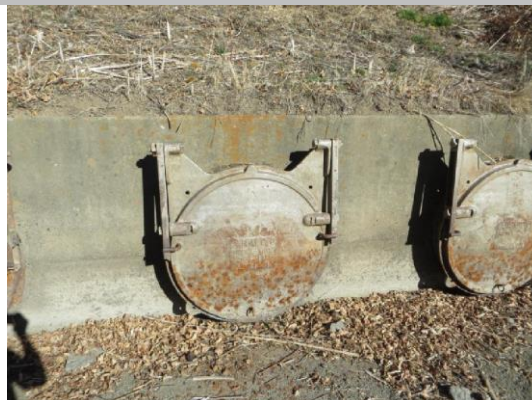
Photo 3 of 3 : UCIP_FA_2018_27965_51666.jpg

Flapgate on headwall at WS toe.

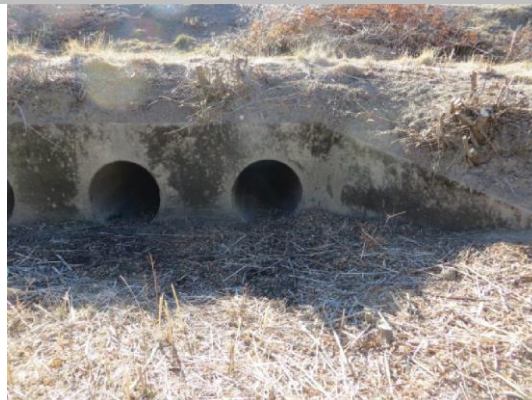
Photo 1 of 3 : UCIP_FA_2018_27967_51671.jpg

Pipe and concrete headwall on LS toe.

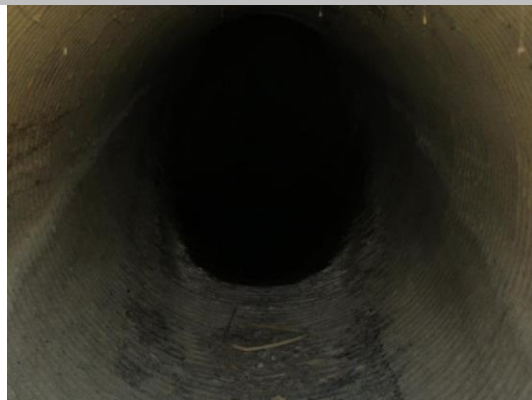
Photo 2 of 3 : UCIP_FA_2018_27967_51670.jpg

Pipe from LS toe.

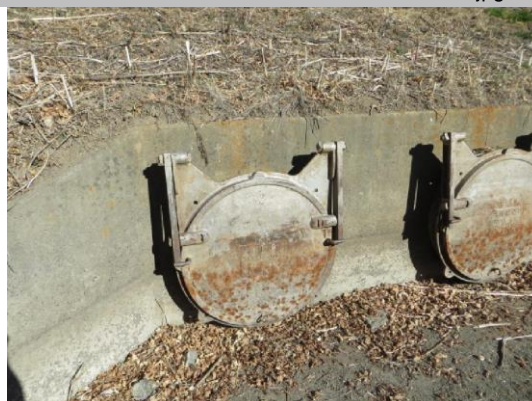
Photo 3 of 3 : UCIP_FA_2018_27967_51669.jpg

Flapgate on concrete headwall on WS toe.

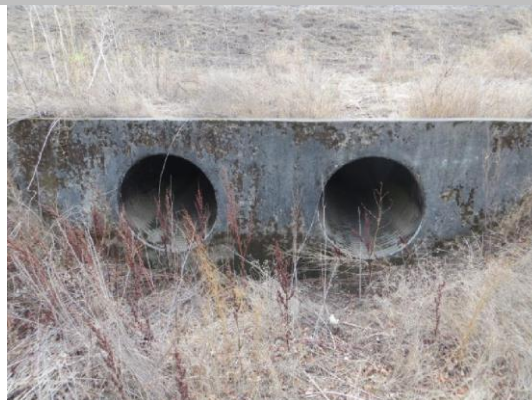
Photo 2 of 3 : UCIP_FA_2018_26947_49792.jpg

Concrete headwall visible on LS toe.

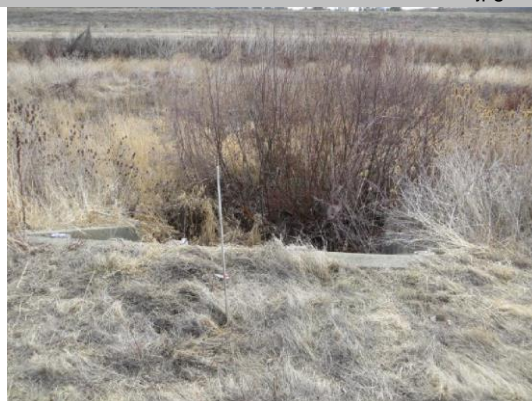
Photo 3 of 3 : UCIP_FA_2018_26947_49791.jpg

Concrete headwall visible on WS berm.

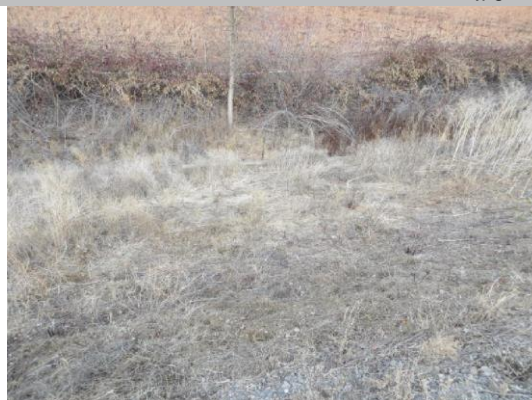
Photo 1 of 3 : UCIP_FA_2018_26948_49797.jpg

Concrete headwall and inlet visible on LS toe.

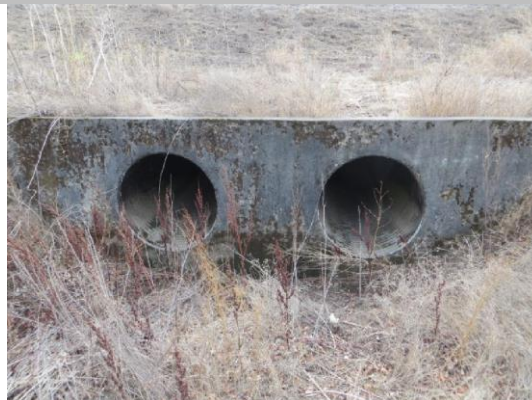
Photo 2 of 3 : UCIP_FA_2018_26948_49796.jpg

Concrete headwall and inlet visible on LS toe.

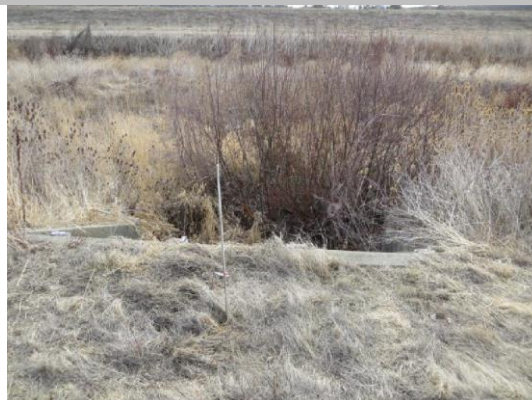
Photo 3 of 3 : UCIP_FA_2018_26948_49795.jpg

Concrete headwall visible on toe of WS berm.

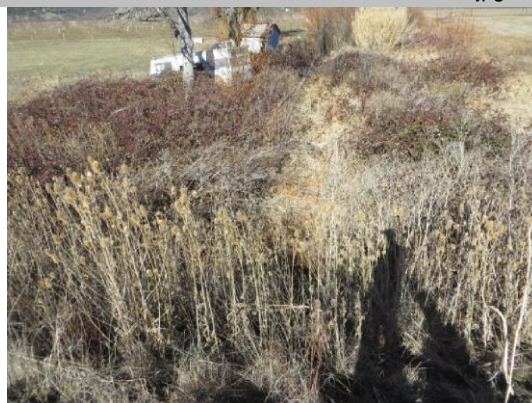
Photo 1 of 3 : UCIP_FA_2018_53332_49754.jpg

Drainage canal at inlet on LS toe.

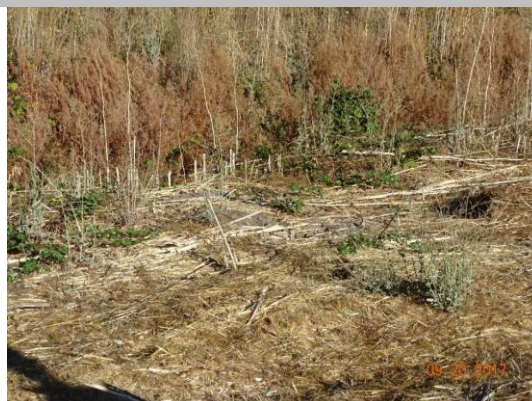
Photo 1 of 1 : FA_2018_NA0009_6_12_20180905_00005.jpg

View of the rodent holes along the landside slope & toe.

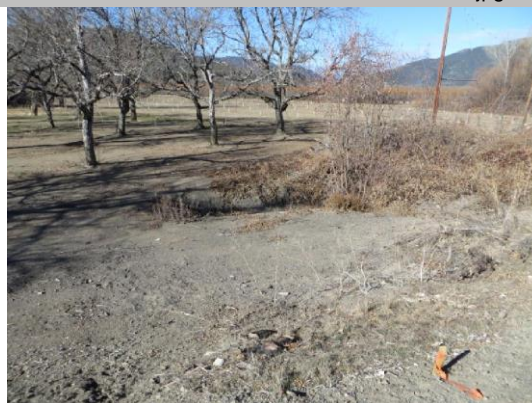
Photo 1 of 3 : UCIP_FA_2018_26924_49762.jpg

Drainpipe visible at LS toe.

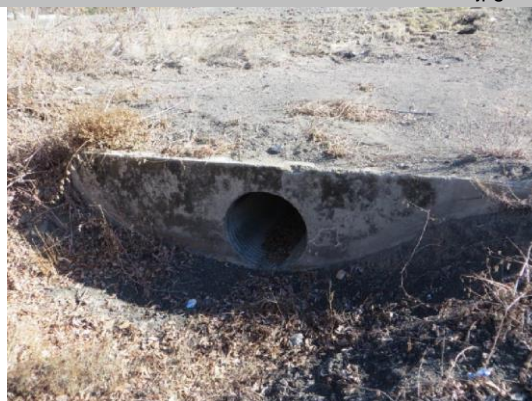
Photo 2 of 3 : UCIP_FA_2018_26924_49761.jpg

Concrete headwall and drainpipe visible at LS toe.

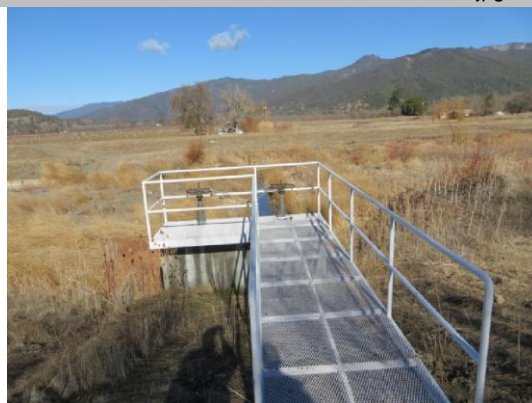
Photo 1 of 3 : UCIP_FA_2018_26897_49712.jpg

Slide gate at steel walkway on WS toe.

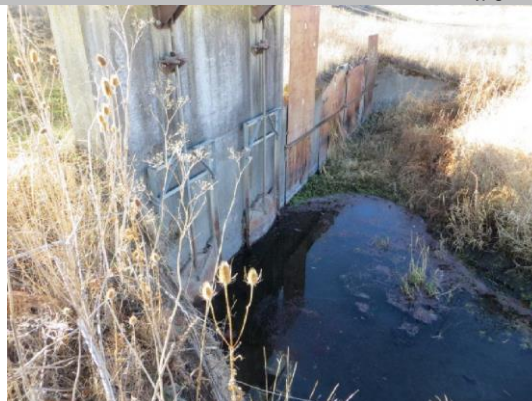
Photo 3 of 3 : UCIP_FA_2018_26897_49710.jpg

Slide gate at concrete headwall on WS toe.

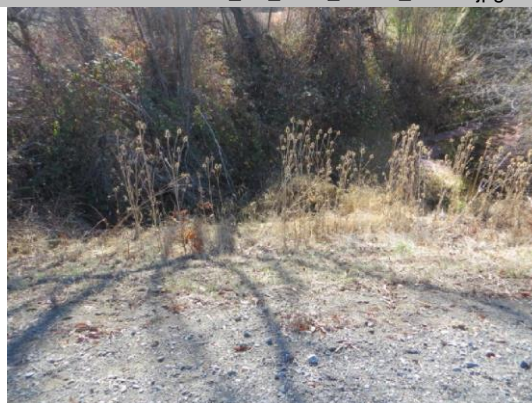
Photo 2 of 3 : UCIP_FA_2018_26891_49681.jpg

Outlet visible at concrete headwall on LS toe.

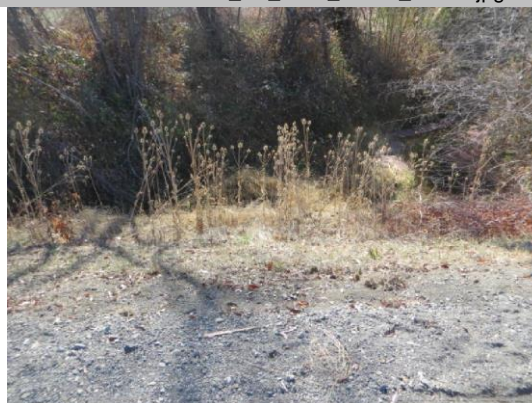
Photo 2 of 3 : UCIP_FA_2018_26888_49665.jpg

Outlet visible at concrete headwall on LS toe.

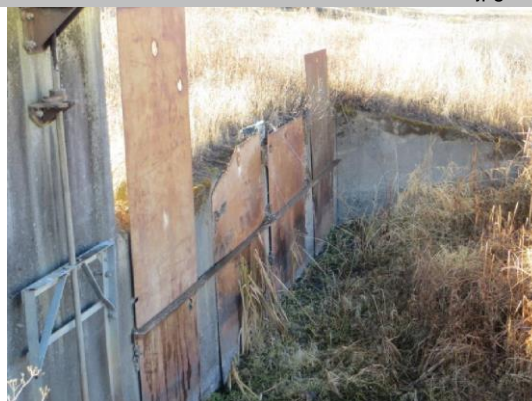
Photo 3 of 3 : UCIP_FA_2018_26888_49664.jpg

Steel slide gate visible at concrete headwall on WS toe.

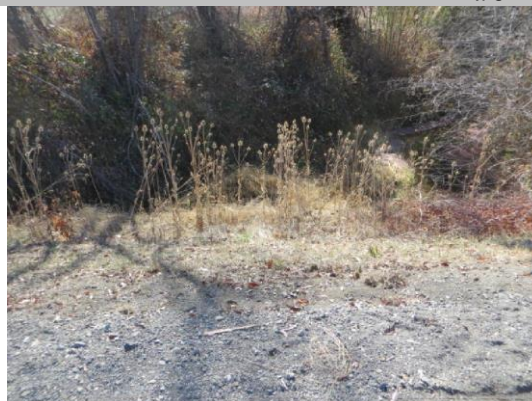
Photo 2 of 3 : UCIP_FA_2018_26885_49633.jpg

Outlet visible at concrete headwall on LS toe.

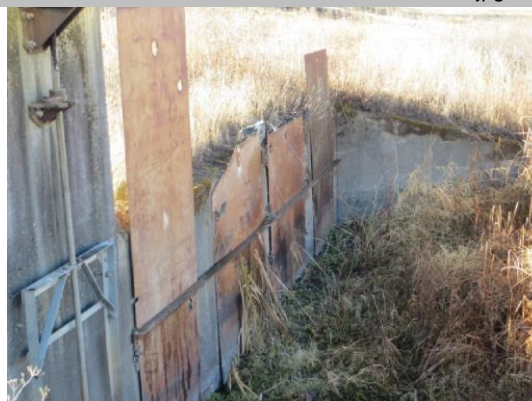
Photo 3 of 3 : UCIP_FA_2018_26885_49632.jpg

Steel plate slide gate visible at headwall on WS toe.

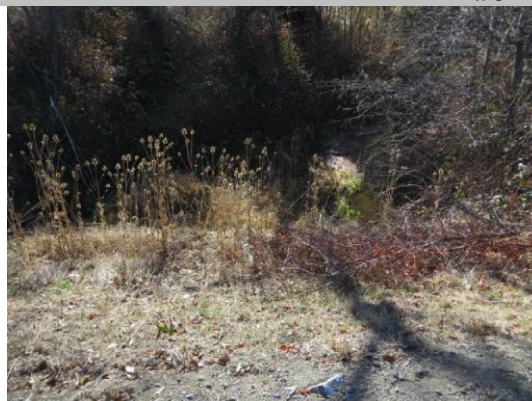
Photo 2 of 3 : UCIP_FA_2018_26883_49621.jpg

Pipe visible at concrete headwall on LS toe.

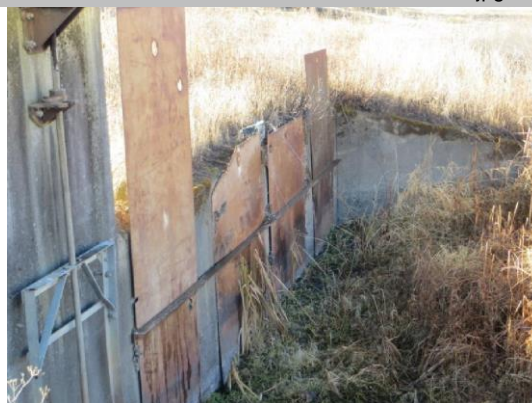
Photo 3 of 3 : UCIP_FA_2018_26883_49620.jpg

Metal slide gate visible at concrete headwall on WS toe.

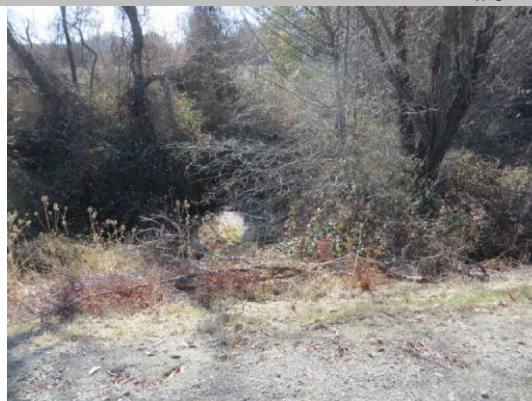
Photo 2 of 3 : UCIP_FA_2018_26877_49609.jpg

Concrete headwall on LS toe.

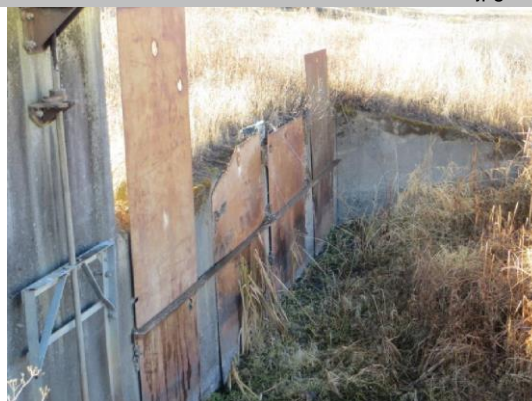
Photo 3 of 3 : UCIP_FA_2018_26877_49608.jpg

Steel slide gate visible at headwall on WS toe.
